AS3959 Bushfire Attack Level Assessment Report

Site Details	
Address:	Subdivision Stage 3 - Lake Treeby
Suburb:	Treeby WA 6164
Local Government Area	City of Cockburn
State:	Western Australia
Description of Building Works	Residential lots for Class 1 Dwellings

Report Details			
Report / Job Number:	2211-67	Report Version	1.0
Assessment Date:	24/11/2022	Report Date	30/11/2022
Assessor Details			
Name:	Rohan Carboon		
Accredited Practitioner	Rohan Carboon Level 3 - BPAD 23160

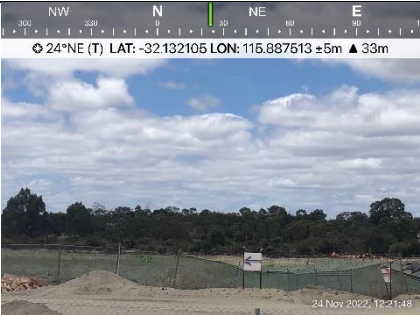
<p>Photo ID: 1</p> <p>Plot Number: 6</p> <p>Vegetation classification or exclusion clause: Class D Scrub</p> <p>Description/justification of classification: Mixed species of shrubs greater than 2m high; 10 – 30% foliage cover.</p>

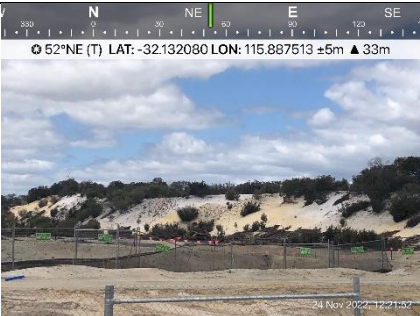
<p>Photo ID: 2</p> <p>Plot Number: 6</p> <p>Vegetation classification or exclusion clause: Class D Scrub</p> <p>Description/justification of classification: Mixed species of shrubs greater than 2m high; 10 – 30% foliage cover.</p>

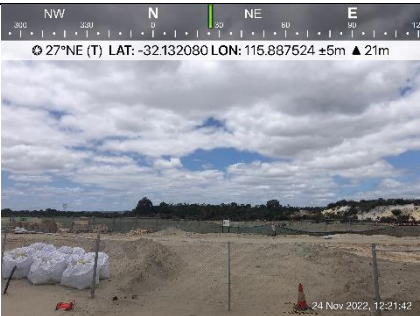
<p>Photo ID: 3</p> <p>Plot Number: 9</p> <p>Vegetation classification or exclusion clause: Exclusion Clause 2.2.3.2 (f)</p> <p>Description/justification of classification: Cleared area to be revegetated into managed parkland/public open space</p>

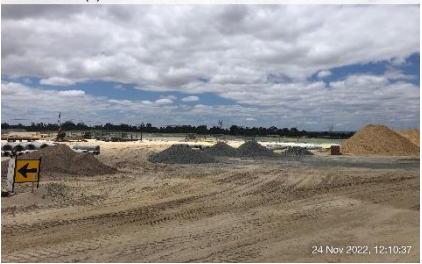
<p>Photo ID: 9</p> <p>Plot Number: 10</p> <p>Vegetation classification or exclusion clause: Exclusion Clause 2.2.3.2(e)</p> <p>Description/justification of classification: Cleared development stages for residential lots – no threat vegetation – minimal vegetation proposed in urban landscape.</p>

<p>Photo 9: A wide, cleared dirt area with some mounds of earth and a yellow sign in the distance. The sky is overcast.</p>
<p>Photo ID: 10</p> <p>Plot Number: 10</p> <p>Vegetation classification or exclusion clause: Exclusion Clause 2.2.3.2(e)</p> <p>Description/justification of classification: Cleared development stages for residential lots – no threat vegetation – minimal vegetation proposed in urban landscape.</p>

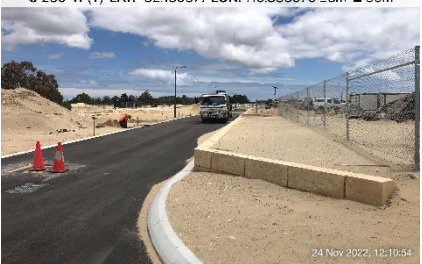
<p>Photo 10: A paved road with a concrete curb and a fence on the right side. A truck is visible in the distance.</p>
<p>Photo ID: 11</p> <p>Plot Number: 10</p> <p>Vegetation classification or exclusion clause: Exclusion Clause 2.2.3.2(e)</p> <p>Description/justification of classification: Cleared development stages for residential lots – no threat vegetation – minimal vegetation proposed in urban landscape.</p>

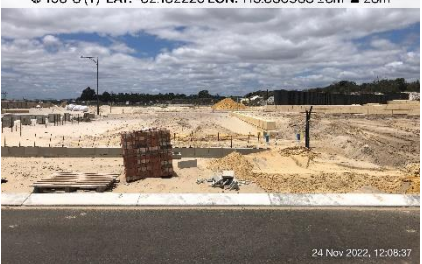
<p>Photo 11: A cleared dirt area with some construction materials and a fence in the background.</p>

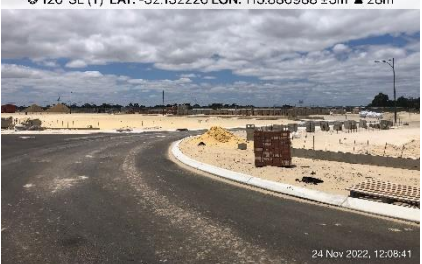
<p>Photo 12: A paved road curving to the right, with a concrete curb and a fence on the right side.</p>
<p>Photo ID: 13</p> <p>Plot Number: 10</p> <p>Vegetation classification or exclusion clause: Exclusion Clause 2.2.3.2(e)</p> <p>Description/justification of classification: Cleared development stages for residential lots – no threat vegetation – minimal vegetation proposed in urban landscape.</p>

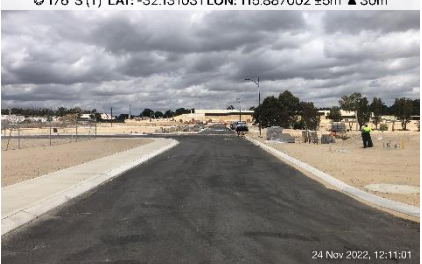
<p>Photo 13: A paved road with a concrete curb and a fence on the right side, similar to Photo 10.</p>

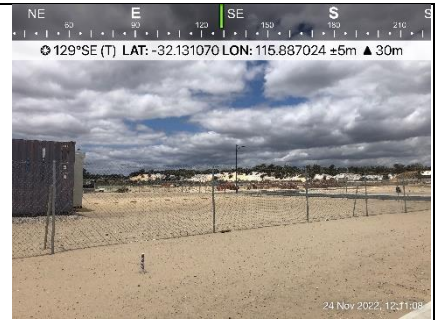
Photo ID: 14

Exclusion Clause 2.2.3.2(e)

Cleared development stages for residential lots – no threat vegetation – minimal vegetation proposed in urban landscape.

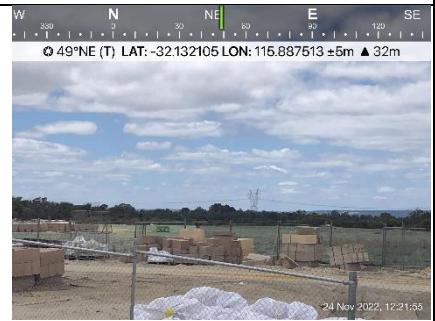
Photo ID: 15

Exclusion Clause 2.2.3.2(e)

Cleared development stages for residential lots – no threat vegetation – minimal vegetation proposed in urban landscape.
