AS3959 Bushfire Attack Level Assessment Report

Site Details	
Address:	Subdivision Stage 6 - Lake Treeby
Suburb:	Treeby WA 6164
Local Government Area	City of Cockburn
State:	Western Australia
Description of Building Works	Residential lots for Class 1 Dwellings

Report Details			
Report / Job Number:	2310-38	Report Version	1.0
Assessment Date:	15/08/2023	Report Date	11/10/2023
Assessor Details			
Name:	Rohan Carboon		
Accredited Practitioner	Rohan Carboon Level 3 - BPAD 23160

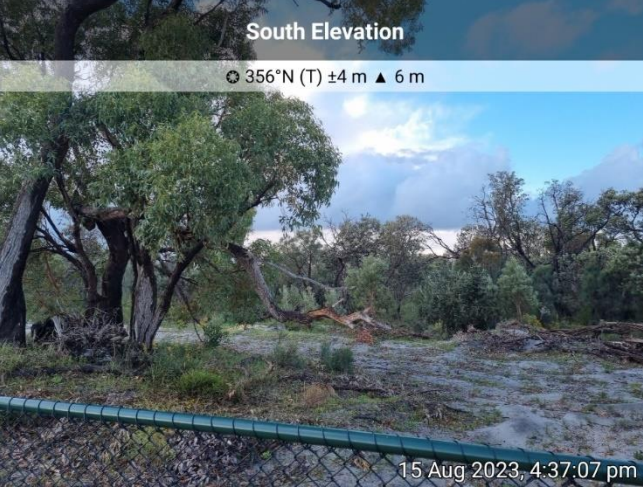
<p>Photo ID: 1</p> <p>Plot Number: 1</p> <p>Vegetation classification or exclusion clause: Class A Forest</p> <p>Description/justification of classification: Open forest 30 – 70% foliage cover with eucalypts and banksia trees and shrubland understorey.</p>

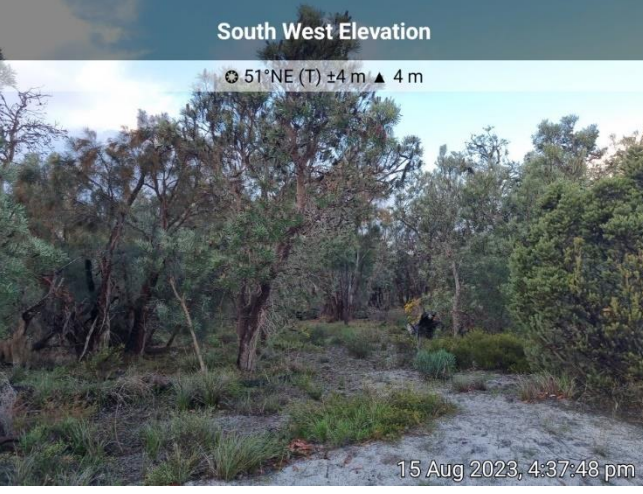
<p>Photo ID: 2</p> <p>Plot Number: 1</p> <p>Vegetation classification or exclusion clause: Class A Forest</p> <p>Description/justification of classification: Open forest 30 – 70% foliage cover with eucalypts and banksia trees and shrubland understorey.</p>

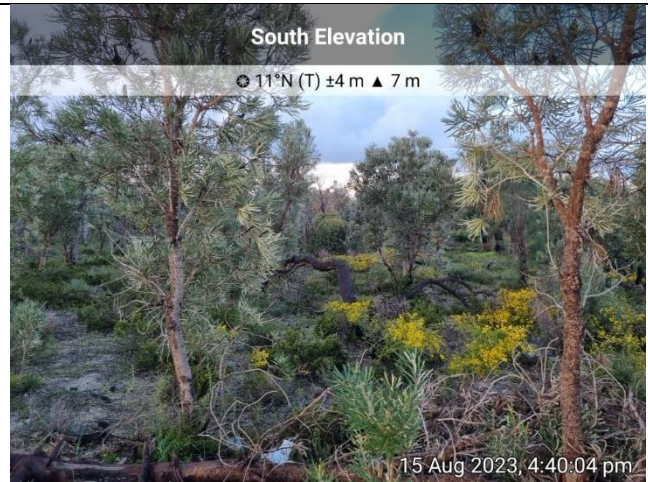
Photo ID: 3

Plot Number: 3

Vegetation classification or exclusion clause:
Class B Woodland

Description/justification of classification: Low
Low banksia trees and low shrubs that mature
less than 6 m in height and open canopy.

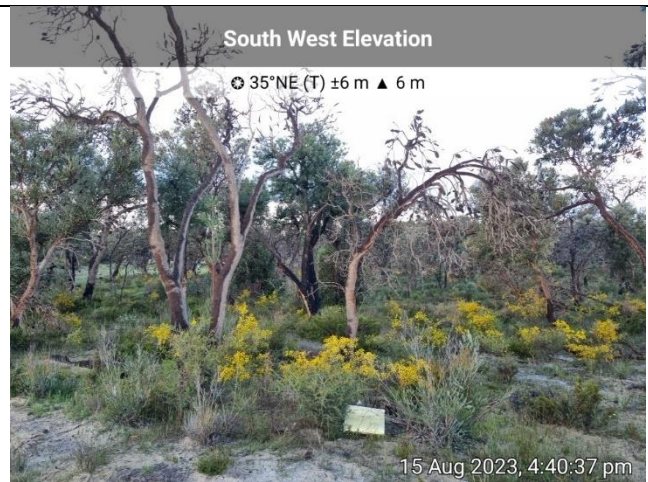
Photo ID: 4

Plot Number: 3

Vegetation classification or exclusion clause:
Low banksia trees and low shrubs that mature
less than 6 m in height and open canopy.

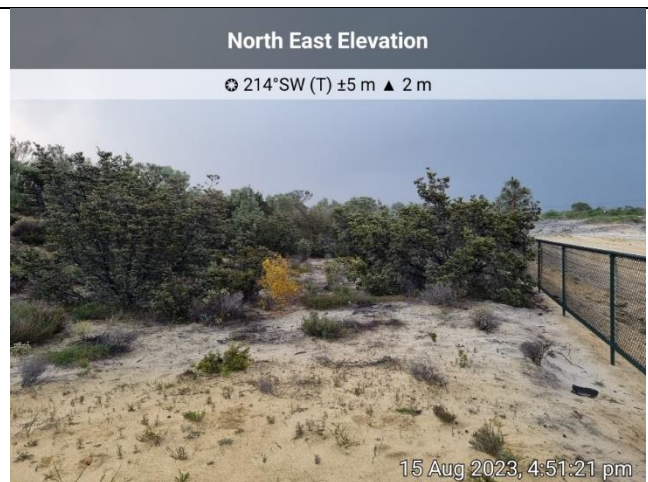
Photo ID: 5

Plot Number: 5

Vegetation classification or exclusion clause:
Class D Scrub

Description/justification of classification:
Mixed species of scrub vegetation 2-4m high.

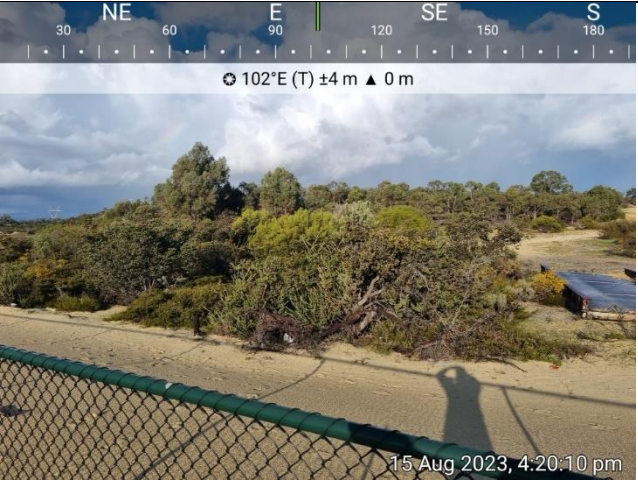
<p>Photo ID: 9</p> <p>Plot Number: 6</p> <p>Vegetation classification or exclusion clause: Class: D Scrub</p> <p>Description/justification of classification Mixed species of scrub vegetation 2-6m high in old sand extraction area.</p>

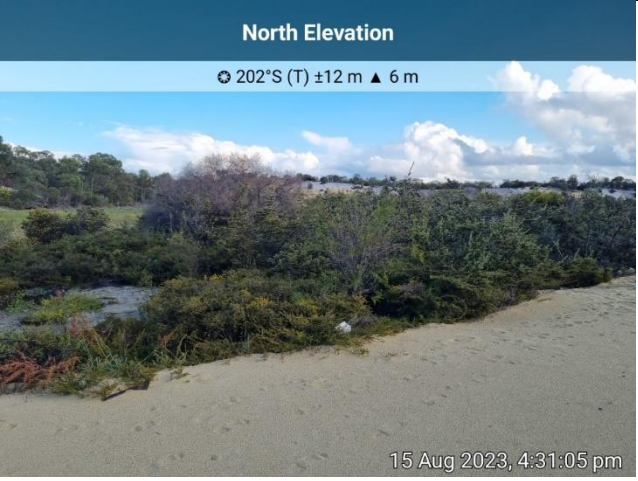
<p>Photo ID: 10</p> <p>Plot Number: 6</p> <p>Vegetation classification or exclusion clause: Class: D Scrub</p> <p>Description/justification of classification: Mixed species of scrub vegetation 2-6m high in old sand extraction area.</p>

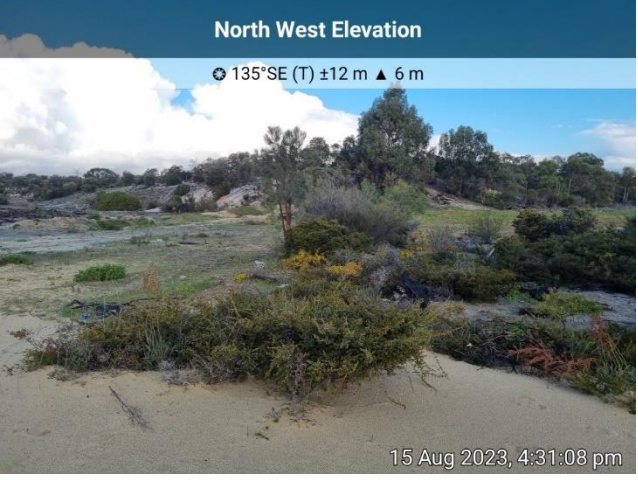
<p>Photo ID: 11</p> <p>Plot Number: 6</p> <p>Vegetation classification or exclusion clause: Class: D Scrub</p> <p>Description/justification of classification Mixed species of scrub vegetation 2-6m high in old sand extraction area.</p>

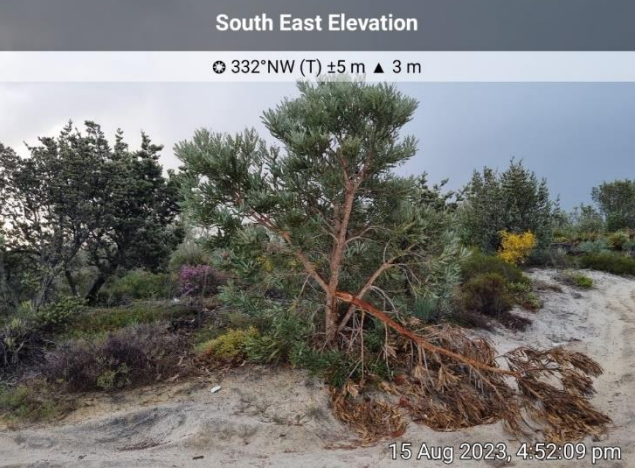
<p>Photo ID: 12</p> <p>Plot Number: 7</p> <p>Vegetation classification or exclusion clause: Class: C Shrubland</p> <p>Description/justification of classification: Sparse banksia shrubs in dominant low shrubland area.</p>

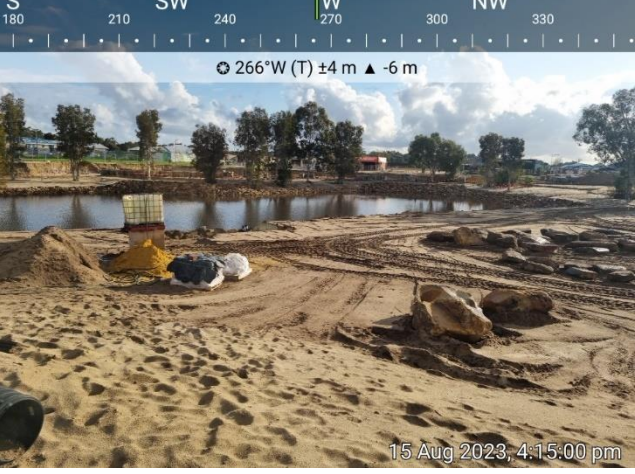
<p>Photo ID: 13</p> <p>Plot Number: 9</p> <p>Vegetation classification or exclusion clause: Exclusion Clause 2.2.3.2(f)</p> <p>Description/justification of classification: Landscaping under construction in public open space to be re-vegetated with low threat vegetation, lawns and park area.</p>

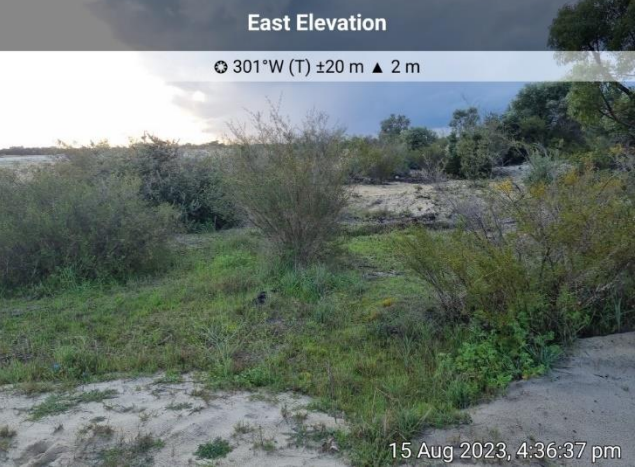
<p>Photo ID: 14</p> <p>Plot Number: 9</p> <p>Vegetation classification or exclusion clause: Exclusion Clause 2.2.3.2(f)</p> <p>Description/justification of classification: Future public open space; to have low threat vegetation.</p>

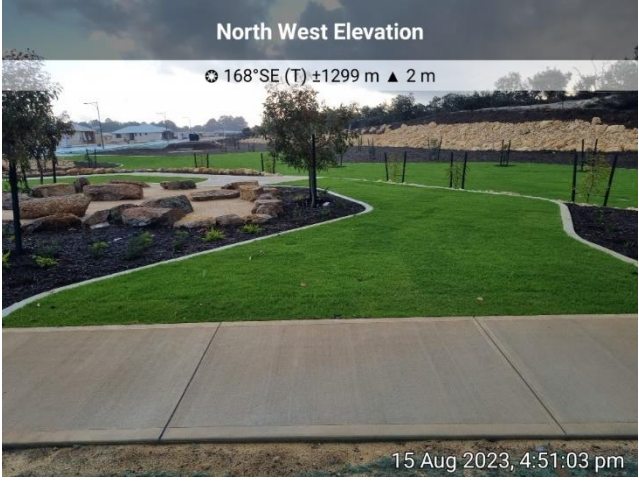
Photo ID: 15
Plot Number: 9
Vegetation classification or exclusion clause:
Exclusion Clause 2.2.3.2(f)
Description/justification of classification:
Low threat vegetation; lawns and maintained gardens in public open space.

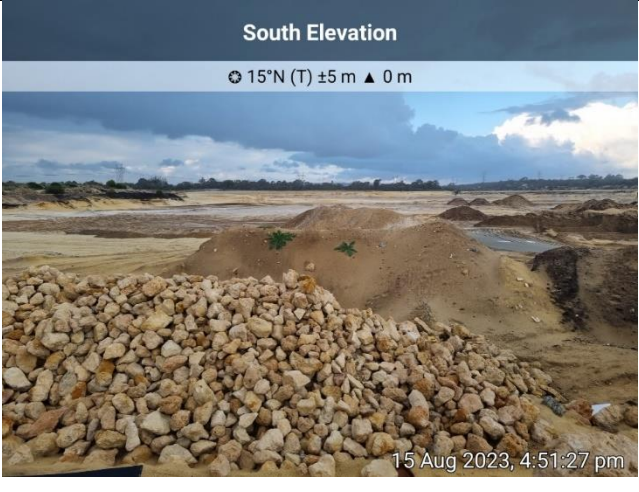
Photo ID: 16
Plot Number: 9
Vegetation classification or exclusion clause:
Exclusion Clause 2.2.3.2(f)
Description/justification of classification:
Low threat vegetation; future lawns and maintained gardens in public open space.

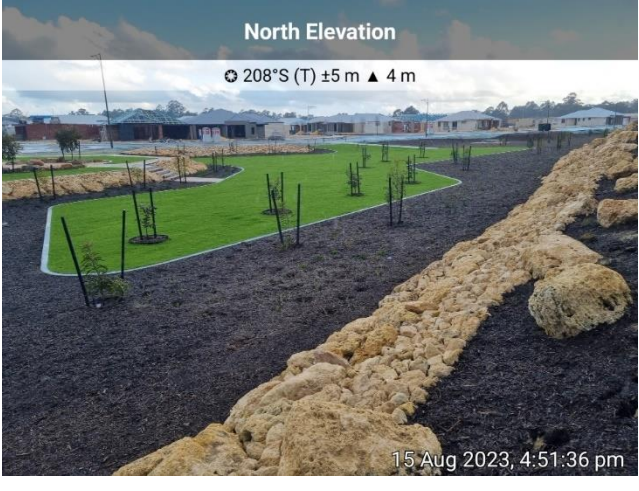
Photo ID: 17
Plot Number: 9
Vegetation classification or exclusion clause:
Exclusion Clause 2.2.3.2(f)
Description/justification of classification:
Low threat vegetation; lawns and maintained gardens in public open space.

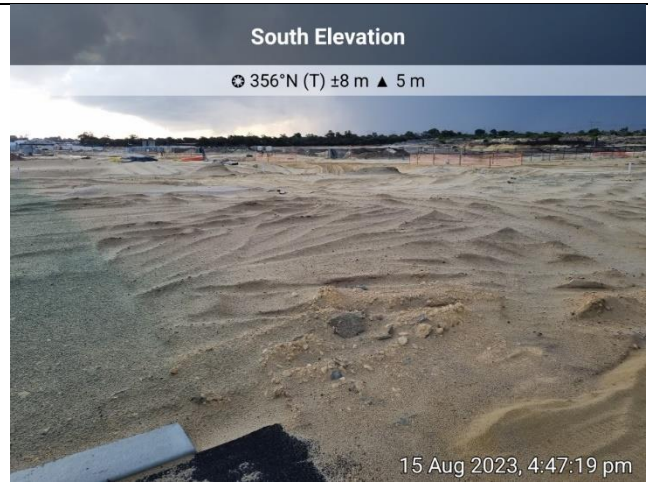
Photo ID: 24

Plot Number: 10

Exclusion Clause 2.2.3.2(e)

Cleared development stages for residential lots – non vegetated area – minimal vegetation proposed in urban landscape.
